PRIORITIZED PROJECT LIST

WOODBURN
& COMPANY
Landscape Architecture, LLC

University of New Hampshire Ravine Action Plan

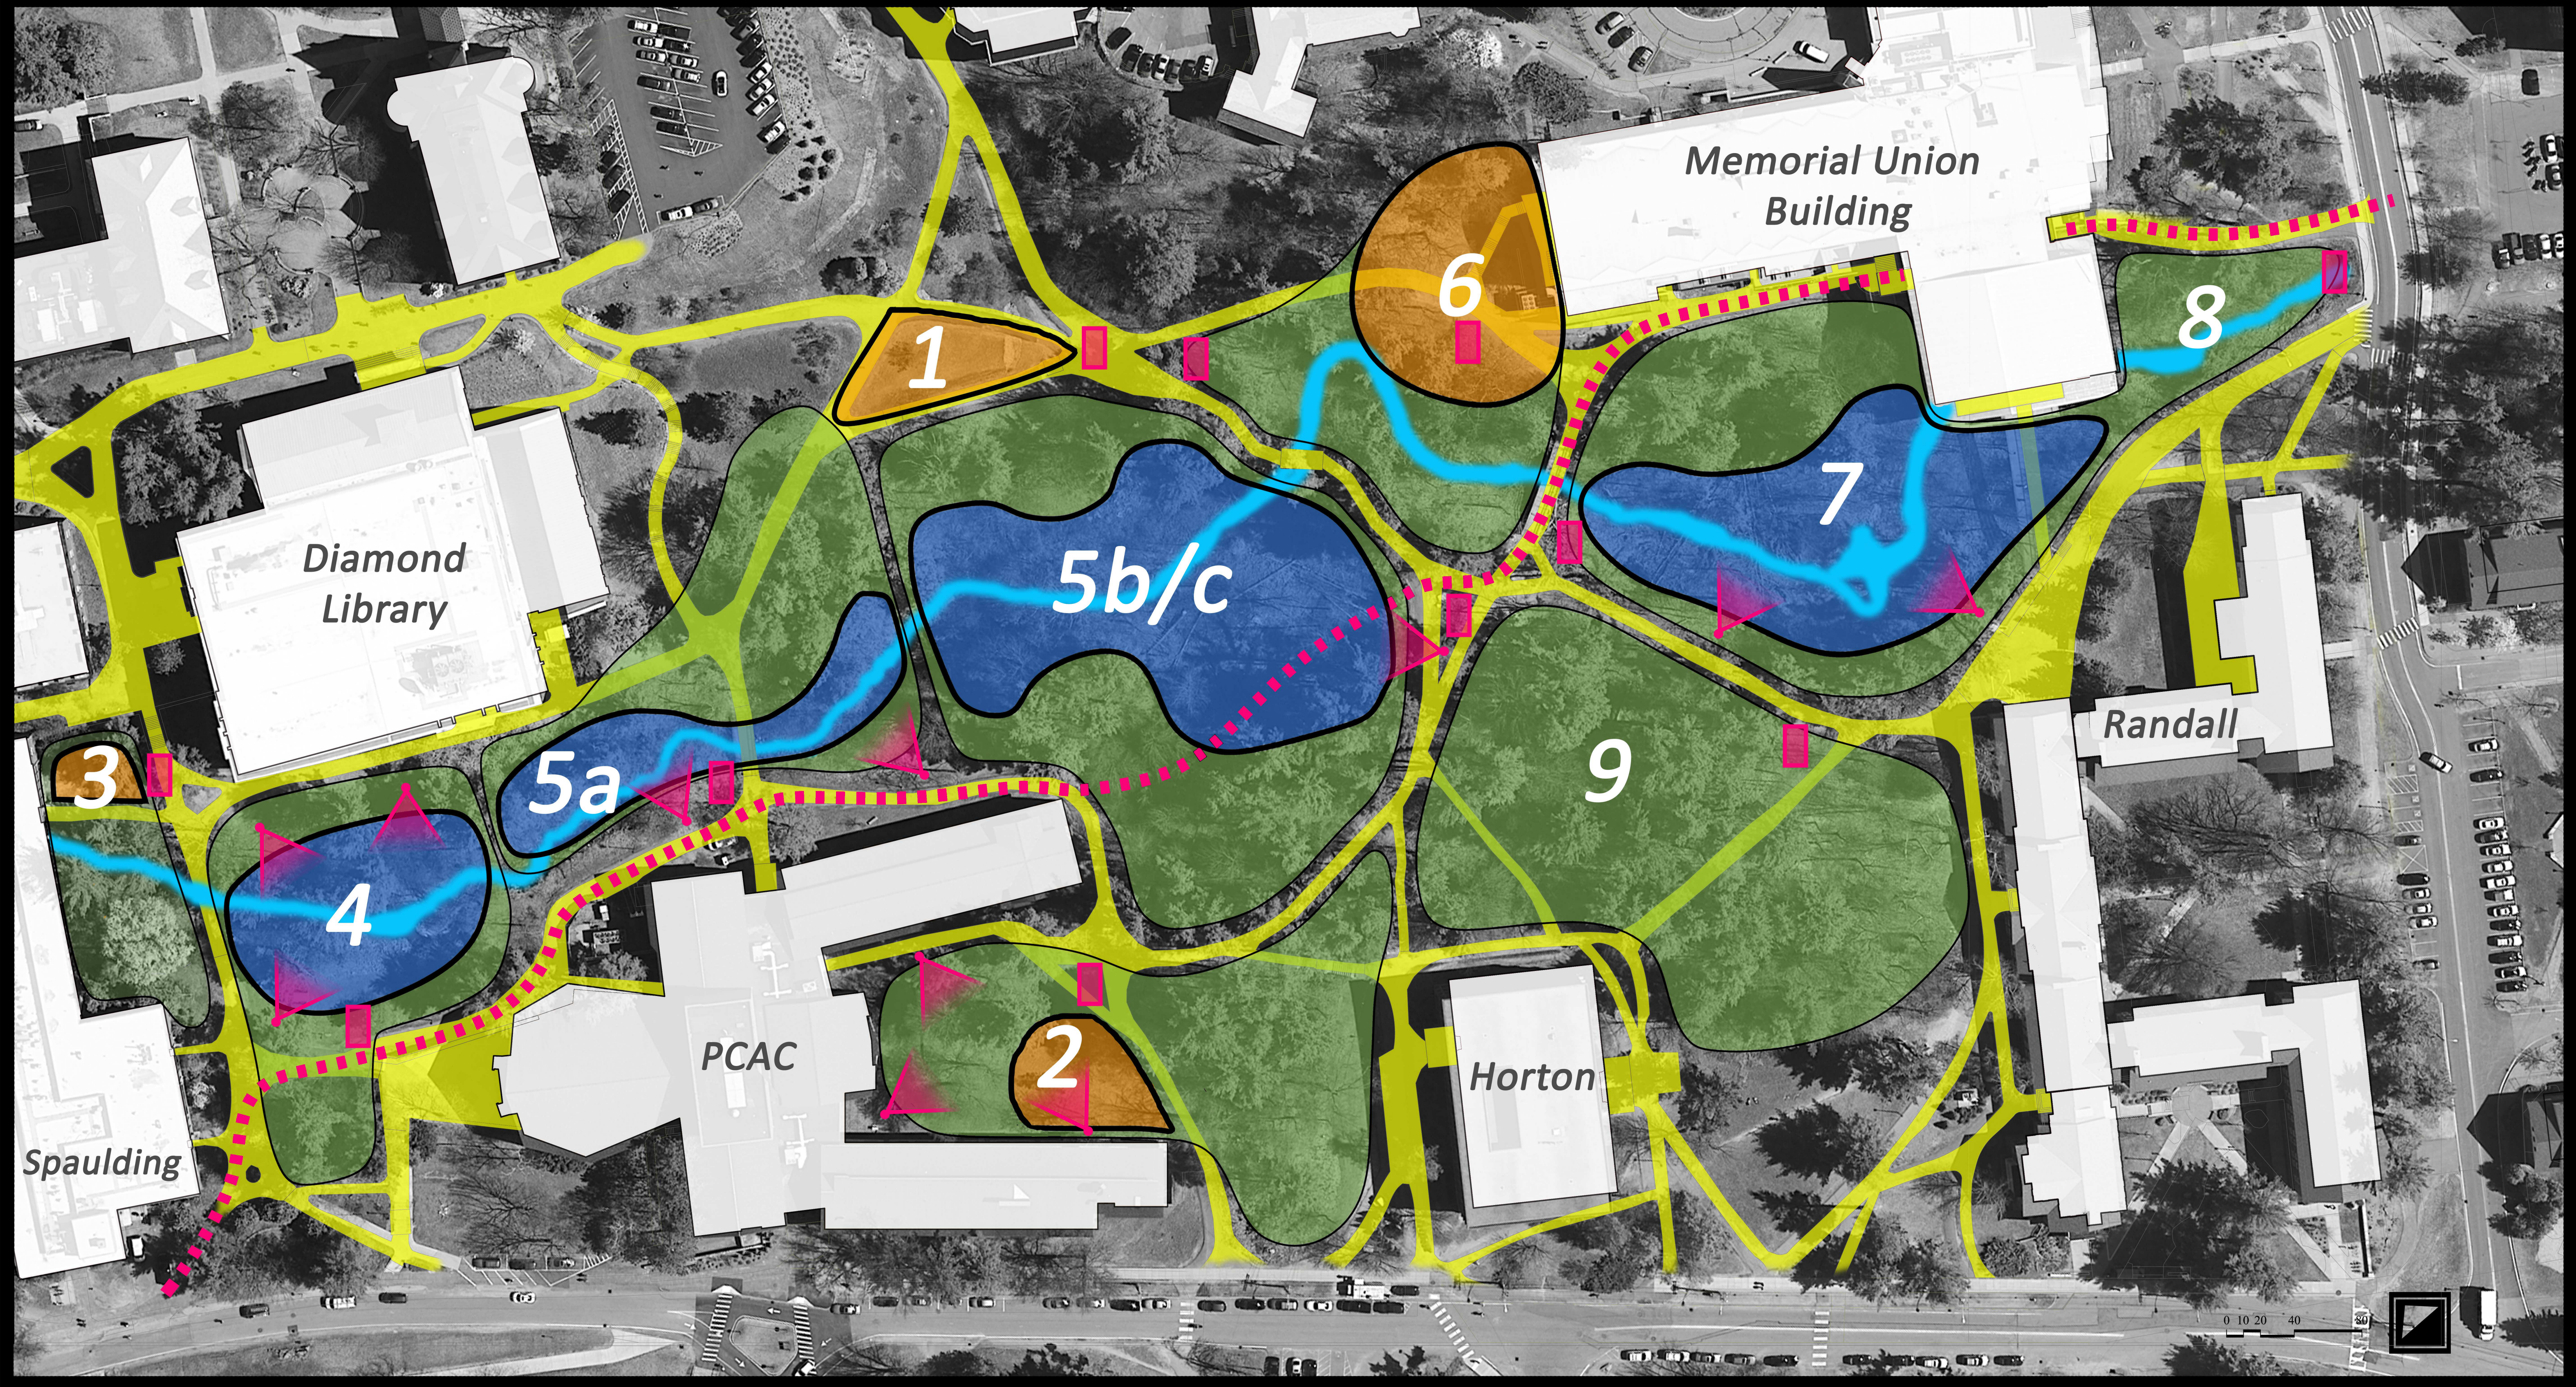
1. **The Dell** (Bio-retention / Raingarden)
2. **PCAC Courtyard** (Bio-retention / Raingarden)
3. **Spaulding** (Bio-retention / Raingarden)
4. **PCAC Pond** (Buffer enhancement)
5. **PCAC College Brook**
 - a. Stream bank erosion control, Log veins
 - b. Wet meadow establishment
 - c. boardwalk
6. **MUB West** (Steep slope erosion control)
7. **MUB Central** (Blow down removals, Forested wet meadow, Log veins)
8. **MUB East** (Invasives removal, Native vegetation restoration)
9. **Horton** (Invasives removal, Native vegetation restoration)

Stormwater Management - Erosion from run-off from adjacent impervious areas has impacted the Ravine and Brook in many locations. Edges of walkways, drainage from roofs and lawn areas, all contribute drainage which flows to the Brook overland and through pipes causing erosion on the way. Effective stormwater management with Bio-retention areas or Raingardens upstream of the Brook will slow the water down, allow more of it to infiltrate prior to getting to the stream, allow for debris and pollutants to be removed prior to entering the stream as well as lower the temperature of water as it enters the Brook.

1. The Dell, collecting and detaining and infiltrating drainage from the Thompson Hall parking lot and the sloping lawn of The Dell.
2. The Rear of Spaulding Hall, collecting and detaining and infiltrating drainage from Conant Courtyard
3. PCAC Courtyard - collecting roof, courtyard and pathway drainage, along with runoff from the Academic Way closed drainage system into a bio-retention area in the courtyard.
4. Southwest Corner of the MUB - There is currently a very steep slope at the southwestern corner of the MUB that is actively eroding. Drainage and erosion cross the path and continues down a very steep slope into the Brook. Mitigation of the steep slope with natural retaining walls and planting uphill of the walkway and re-vegetation of the bank below the walk will help to eliminate this issue.

1. Log Veins - The stream channel has deepened overtime, removing the potential for the stream to top its banks and inundate the floodplain areas. Log Veins were discussed as a means to slow down the rush of water that continues to scour the channel.
2. Adjust the level of the Brook - In flood plain areas reestablish the potential for utilization of the flood plain by either lowering the plain or raising the channel of the stream creating either an open wet meadow in the case of the flood plain area by PCAC or a forested wet meadow in the area adjacent to the MUB.

ADA Accessibility - The Ravine Master Plan by HLTurner Group and CRJA recommended the installation of a boardwalk through and across the Ravine. This pedestrian connection would provide an accessible path through the Ravine, connecting users directly to this resource without the environmental damage associated with standard asphalt pathways.
